CITY OF BALTIMORE SMOKE TESTING OBSERVATION SUMMARY LOW LEVEL SEWERSHED

BALTIMORE CITY PROJECT 1029 REI/DRAYCO

Unique Test ID: 591 Date: 09/03/2008 Basin: LL - 44 Manhole ID: S19I__036MH Defect No: OB01 Supervisor: E.R. Crew: 04 Dye Test Recommended: N

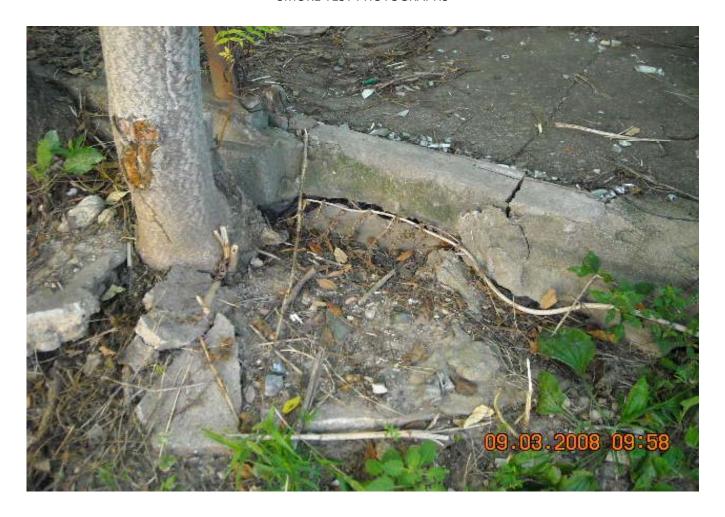
Photograph No: OB01-01 Filename: 1029-591_OB01-01.jpg

Location: 2174 HOLLINS ST.

Source Type: 02 Service Line Sector: 02 Private

Location: 08 Yard - Back Severity: 02 Trace Drainage Area: 5

Comments: SMOKE IS COMING FROM THIS HOLE IN CURB ADJACENT TO TREE.
